IMCA Safety Flash 25/20

MONTH 2020

1 Emergency Lithium battery failed catastrophically in a diving bell

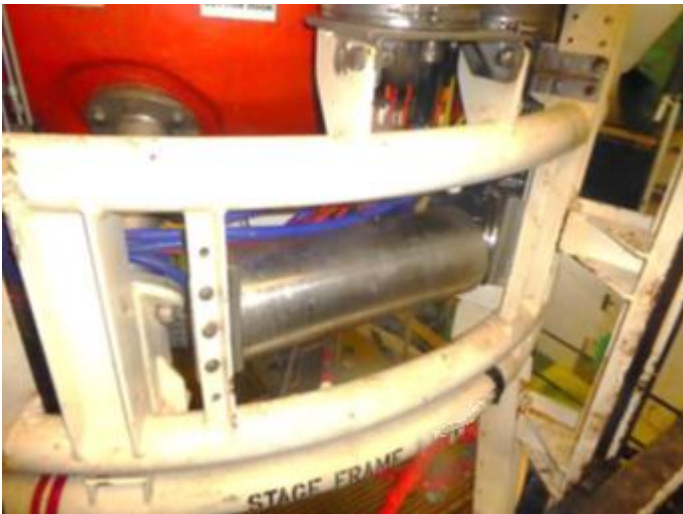
Battery pack (silver cylinder) located within the Bell Frame

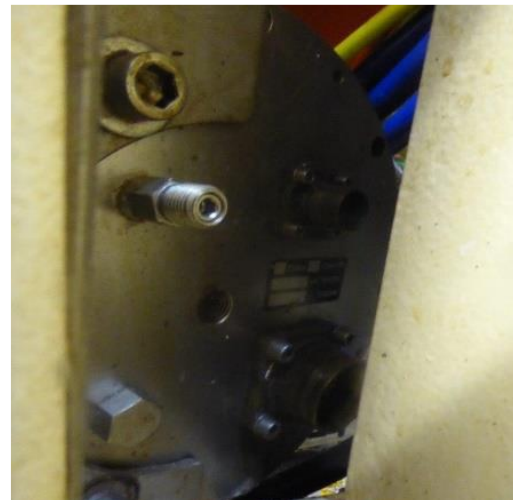
Check valve location on the battery pack

Crucially, the original valves were only threaded on one side with a male thread whereas the replacement type had the same male thread at each end. A second thread on the new valve was not required as it does not connect to anything. This identical second thread introduced the potential for the new valves to be fitted in the wrong orientation.

The battery pack pod had flooded through an incorrectly fitted check valve, causing the failure of the pod and subsequent fire.

- ♦ Review of similar Emergency Battery Pack pods to review the check valves fitted to ensure they cannot be fitted incorrectly. Check valves with male/male threads to be removed;
- ♦ Ensure that a thorough and appropriately technical Management of Change (MoC) process is carried out when changing out dive related components and equipment;
- ♦ Personnel involved should ensure that they have a thorough understanding of the most appropriate immediate actions in the event of a Lithium type battery fire.

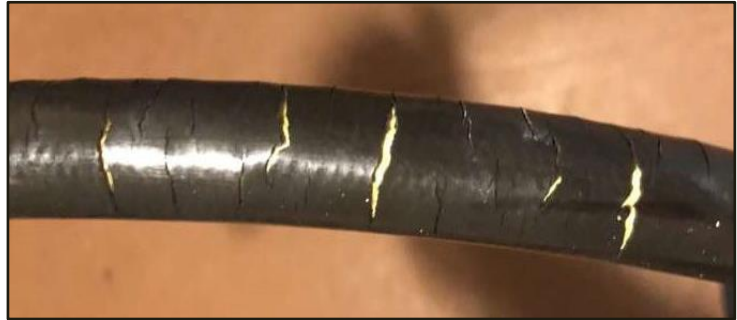
The hose had been in place since 2010 and there was substantial degradation along its full length. The hose was not identified on a hose register and therefore not subject to any planned maintenance or inspection regime.

- ♦ Ensure all hoses are accurately identified and recorded on a hose register system;
- ♦ Ensure hoses are subjected to a thorough visual and tactile inspection as per planned maintenance instructions;
- ♦ Our member also:
 - Ensured adequate 'Restricted Access' signage is posted at all entrances to the nitrogen storage area;
 - Ensured suitable low oxygen detection alarms are installed within the immediate area.

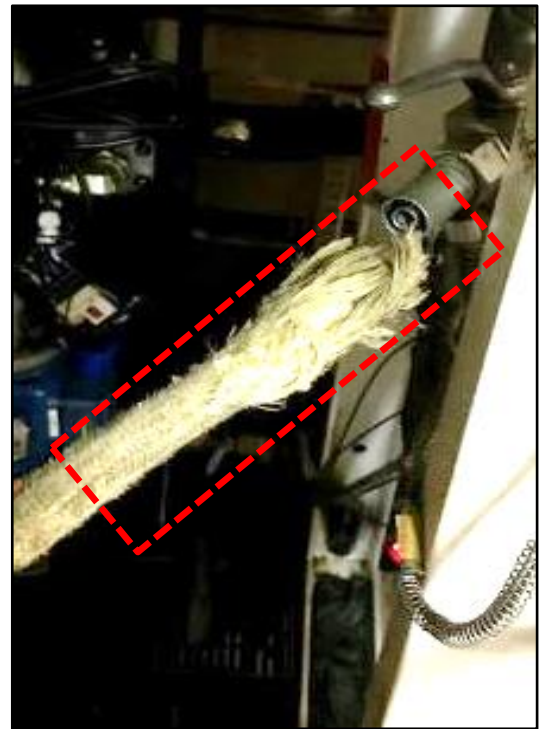
It was later identified that a supply hose had detached from its ferrule and approximately 165,000 litres of pure nitrogen was released into the room. Consequently this reduced the oxygen levels in the room to approximately 17.4% (normal oxygen content in the atmosphere is 20.8%).

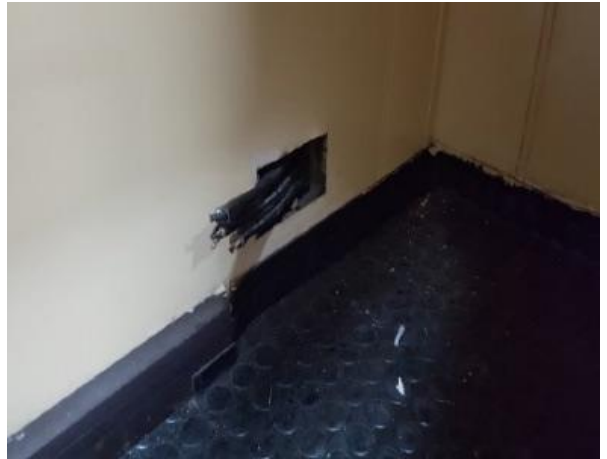
Whilst tidying a mobile office (freight) container, an employee sustained a mild electric shock by inadvertently touching an exposed live electrical cable which was obscured by several boxes below a desk. The cable had been left in position following the removal of a piece of fixed equipment whilst the container was in storage (out of use).

- ♦ Checks on the container, pre and post mobilisation, did not identify the potential risk;
- ♦ No formal verification of the condition and safety of the electrical installation in the container had been carried out prior to energising.

- ♦ Isolated and inspected the container electrical installation and the termination of exposed electrical cables;
- ♦ Reviewed and assessed mobile container electrical installations elsewhere in its operation;
- ♦ Developed and implemented formal work instructions for the fit out and/or modification of mobile offshore containers including the electrical installation.

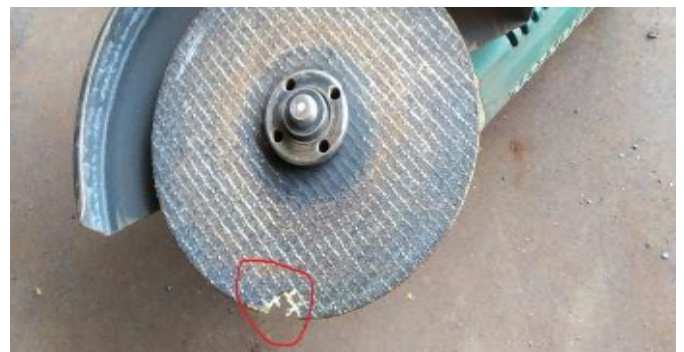
Grinding machine was observed as used with damaged grinding disc. Broken disc projectile could potentially cause serious injuries. Many other workers have been injured when angle grinders have kicked back, causing cuts and lacerations.

- ♦ Lack of awareness of hazards associated with use of damaged grinding discs.
- ♦ The task specific risk assessment did not cover the associated risks and relevant control measures, such as monitoring of wheel condition by user;
- ♦ There was a violation of company SMS requirements relating to the use of electrical tools and equipment;

- ◆ Conduct inspection and check condition of all grinders & discs on vessel;
- ◆ Ensure damaged discs are thrown out and not re-used;
- ◆ Refresher training presentation on abrasive wheels safety for crew.
