Defective Harness Buckle

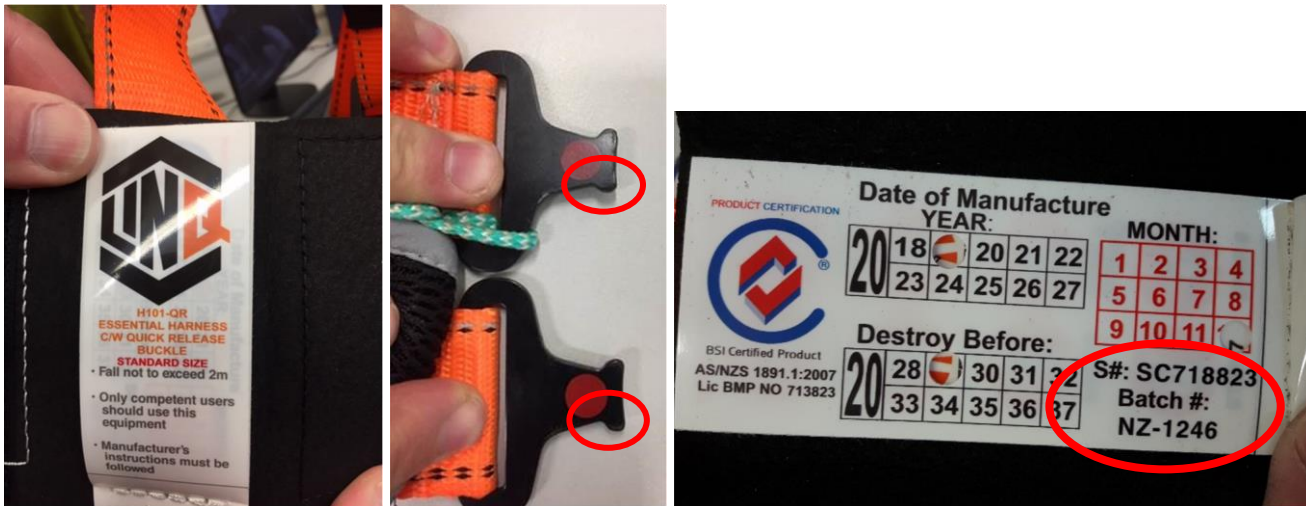
The harness was manufactured in December 2019, and is from batch number NZ-1246

The clip on the chest strap buckle was found to be slightly smaller on one side. This manufacturing defect had not been previously identified.

All LINQ H101-QR harnesses from Batch number NZ-1246 are to be removed from service immediately
