Electrical Injury

Incident Description: An electrical worker was repairing a faulty stop button on the distribution bagging line panel when they brushed against an exposed live 230 volt terminal. Fortunately the shock was minor in nature due to the mechanism of contact with no harm to the worker. The event was reported to WorkSafe NZ the following morning as the incident was recorded in MySafety only by the new Distribution supervisor and acting A&I team leader but was not escalated as required.

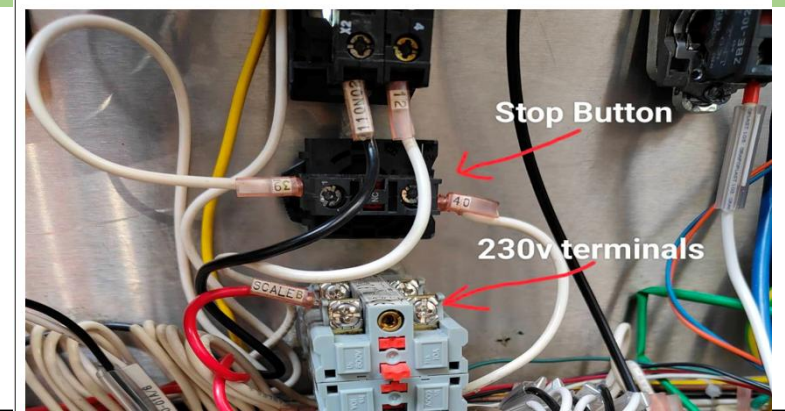
No labelling present to indicate true function of 230v component along with misleading lead labels present indicating that 230v line was for a 'Scale' (usually 24 volts) instead of 'conveyor motor Switch' (with motors typically being 230+ volts).

Old obsolete 230 Volt contact had no touch protection (as now required by current regulations).

Replace any old obsolete 230 Volt contacts with compliant componentry (i.e. compliant touch protection).

Install signage that clearly indicates the presence of 230 volt terminals within control panels (especially those that contain predominantly 24 volt circuits).

Confirm that all electrical componentry within a 300mm radius of the equipment to be worked on must be tested prior to commencing work to identify live componentry and voltages.
