Worker Pinned by Container

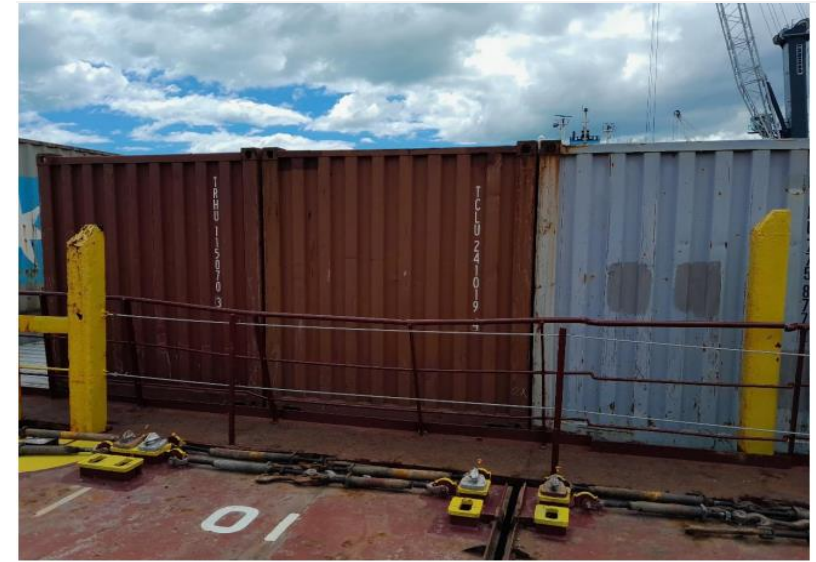
A container hit a continuous pipe hand railing as it was being loaded. The railing then bent inwards towards the walkway. The railing contacted the employee, who was approximately 1m away behind another container (away from the moving container, as per standard procedure), giving guidance to the crane driver.

Figure 1 - Right-hand brown container was the container that hit the railing. The stanchion on the left is where the person was standing.

An inspection process will be added to identify and eliminate risk from railings on bay walkways that are not sectioned.

This hazard has been eliminated by closing walkways with similar hand railing configurations where containers are being loaded at the same height, and there is a risk of hand railings being contacted
